# Characterization of 304 Stainless Steel Material in Food Tray

Food tray,  
stainless steel 304,  
characterization,  
whole-region AFM

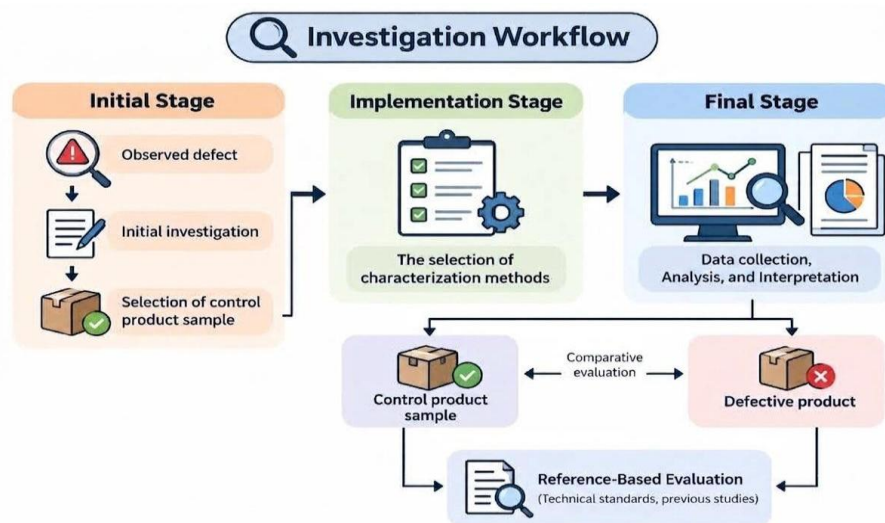
**Figure 1.** Schematic/Flowchart of research

This research begins with a preliminary investigation of the defective Food tray A using SEM-EDS to assess its apparent material composition and investigate the initial suspicion of grade nonconformity associated with the defects observed in the finished product. The preliminary findings then guided a more comprehensive characterization of Food tray A in comparison with Food tray B as the control product, covering chemical composition, mechanical properties, and surface topography. The results obtained from both food trays were subsequently evaluated against relevant technical standards

A novel comparative approach is applied in this research. While previous studies generally compared pre-formed sheets with the formed products, the comparative characterization in this study focuses directly on finished commercial products following the forming process [2]. The primary object of this study is an affected commercial SUS304 food tray measuring  $280 \times 220 \times 55.6$  mm, designated as Food tray A. For baseline comparison, a commercial food tray without observed issues, measuring  $280 \times 220 \times 44.5$  mm, was acquired and designated as Food tray B. The systematic workflow for this post-forming product failure analysis is presented in Figure 1 below..

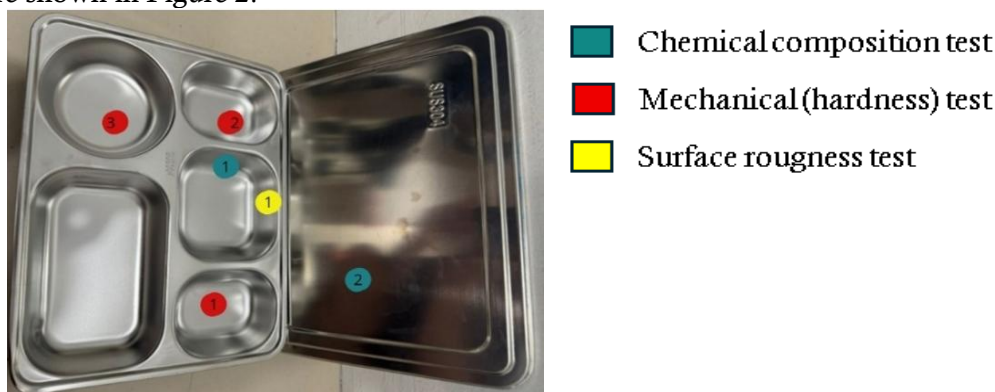
**Figure 2.** The Product Areas for Material Characterization

The sampling technique in the context of this research in the form of test samples (specimens) in this study is non-probability sampling. The selection of the area for material characterization was done using a mixed technique, namely convenience and purposive sampling. The sampled areas of the Food tray are shown in Figure 2.

The determination of the observation area for the material composition value is based on the principle of convenience, where the availability of the test specimen area must be flat and the testing cost efficiency is lower [15]. The observation area for mechanical performance in the form of material hardness is conducted purposively. As reported in previous studies [2-3], the base of the food tray undergoes the least deformation, making it an ideal region to evaluate the work hardening level of both product samples against the standard stainless steel blank (JIS Standard  $\leq 200\text{HV}$ ). The observation area for surface characteristics, such as roughness, is also conducted based on certain considerations (purposive), where the wall area has the maximum deformation level during its formation, as reported in previous studies, thereby significantly increasing the surface roughness values [3],[11-12]. Thus, the product wall area becomes an ideal candidate for surface roughness characterization in response to initial findings of a dull appearance as an indication that the material has a higher roughness level. However, both types of techniques (convenience & purpose) are susceptible to researcher bias and cannot be generalized [15].

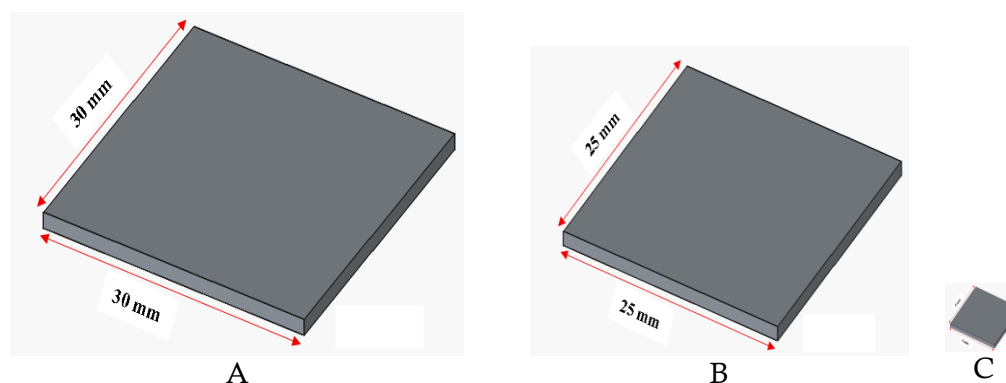
**Figure 3.** Dimension of specimens. A.) Chemical composition test (30x30mm), B.) Surface roughness test (25x25mm), C.) Hardness test (5x5mm).

Based on Figure 3 above, both food trays were cut using aviation snips according to the area of each type of test conducted. The thickness of the test specimen depends on the area of the test sample. The measurement of the food tray's thickness was conducted 10 times using a micrometre with an accuracy of 0.001 mm, randomly distributed across the base, walls, and lid of the food tray. Table 1 below shows the thickness values for each area on both food trays.

The test samples were cut using fine shearing with minimal deformation. The dimensions of the test specimens for each type of Food tray are shown in the Figure 3.

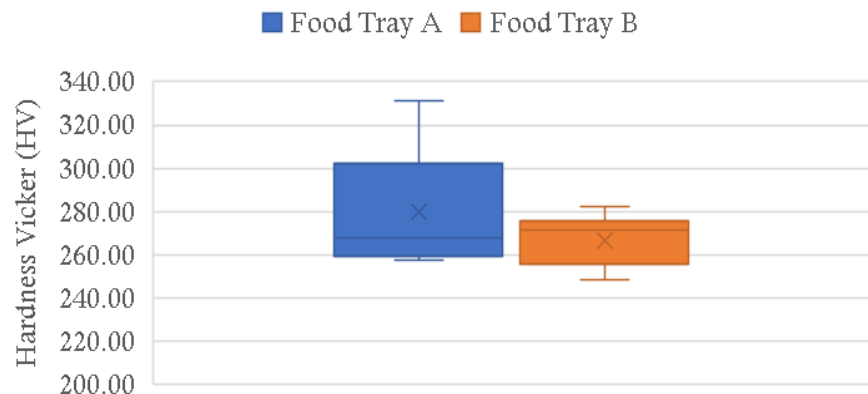
**Figure 4.** Boxplot of Microvicker hardness values for Food tray A and Food tray B

The local mechanical response can be evaluated based on the distribution of Vickers hardness values presented in the boxplot (Figure 4). Food Tray B, serving as the control sample, exhibited a narrower distribution of HV values, whereas Food Tray A showed a wider distribution. Although the median hardness of Food Tray B was slightly higher than that of Food Tray A (271 HV > 267 HV), Food Tray A exhibited a higher mean hardness (279.80 HV > 266.4 HV). The difference between the median and mean hardness values for Food Tray A indicates a distribution influenced by relatively high hardness measurements, including several values exceeding 300 HV. Therefore, the results do not indicate that Food Tray A had a higher overall hardness level than Food Tray B. Rather, the more prominent characteristic of Food Tray A was its greater local hardness variation, indicating a more heterogeneous mechanical response compared with the control sample.

The locations corresponding to higher hardness measurements may represent regions that experienced more intensive deformation and work hardening [20-23]. Such conditions can reduce the local capacity for plastic deformation and potentially increase susceptibility to cracking if these regions undergo further deformation or sufficiently high loading. Accordingly, the findings shift the interpretation of Food Tray A's susceptibility to failure from its overall hardness level toward the local variation in hardness and the degree of local work hardening developed during the forming process.

As shown in Table 3, the median hardness values of Food Trays A and B (267 and 271 HV, respectively) were comparable to or higher than the hardness values reported in previous studies of SUS304 deep-drawn products, which ranged from 258 to 268 HV. Although the products differed in geometry and configuration, the comparable hardness levels suggest that the six-compartment food tray, with its relatively complex geometry, warrants particular attention in optimizing the forming process.

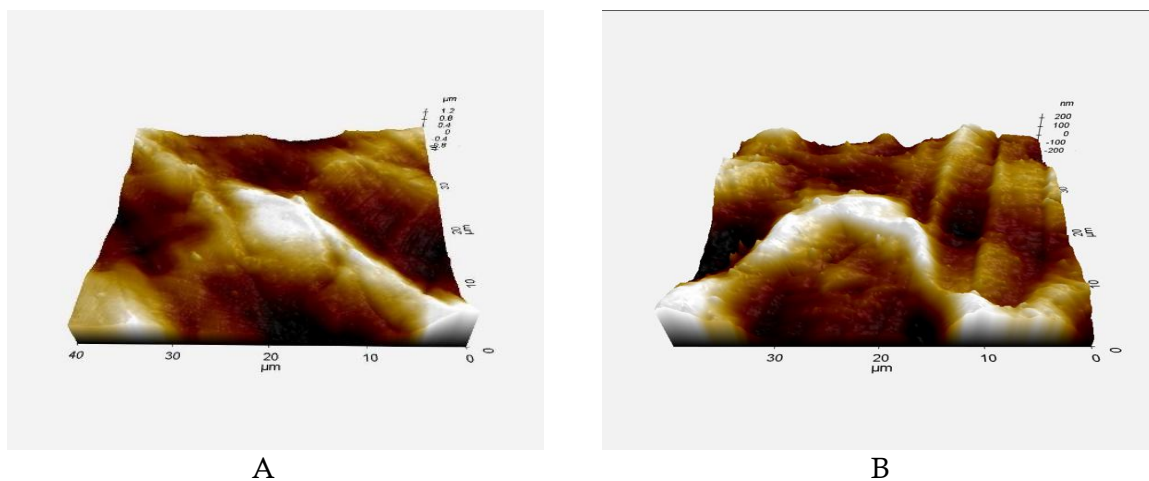
**Figure 3.** Surface topography 3D characterization result. A) Food tray A specimen testing, B) Food tray B specimen testing

The surface topographies of Food Trays A and B shown in Figure 3 reflect a combination of the initial surface characteristics of the metal sheets (e.g., 2B or BA surface finishes) and topographical changes occurring during forming, including plastic deformation during the deep-drawing process [25-26]. Because the initial surface finishes of the two products were unknown and were not specifically characterized in this study, their contributions to the final topography cannot be quantitatively separated from those associated with the forming process. Therefore, the discussion focuses on the

observed topographical characteristics and their potential relationship with plastic deformation during deep drawing. To further quantitatively characterize the observed differences in surface topography, the minimum and maximum surface heights, together with the Ra, Rsk, and Rku parameters, were obtained through whole-region analysis of the AFM surface maps and are summarized in Table 4.

Both Food Tray A and Food Tray B exhibit surface profiles dominated by peaks ( $R_{sk} > 0$ ) with asymmetric characteristics. However, the degree of surface asymmetry is greater in Food Tray A than in Food Tray B ( $0.504 > 0.294$ ). Food Tray A exhibits a leptokurtic surface distribution, characterized by highly pronounced peaks and deep valleys ( $R_{ku} > 3$ ). In contrast, Food Tray B exhibits a platykurtic distribution, characterized by broader, flatter, or more rounded peaks and valleys ( $R_{ku} < 3$ ).

This anomalous surface condition is strongly suspected to be present in Food Tray A, which exhibits greater asymmetry and highly pronounced peaks accompanied by deep valleys ( $R_{ku} > 3$ ). High local strain may contribute to irregular grain orientation, resulting in a very deep valley ( $-0.89 \mu\text{m}$ ) adjacent to a pronounced surface peak ( $1.4 \mu\text{m}$ ). Conversely, finer grains may improve mechanical performance during sheet metal forming [12],[31-32]. Food tray B exhibits broader, flatter, or more rounded peaks and valleys. This condition may reflect a more uniform surface deformation, thereby limiting the formation of extreme-amplitude valleys and peaks such as those observed in Food tray A. Overall, the average surface roughness (Ra) of the two sample types falls into different surface roughness grades. This difference in surface classification is presented in Table 5.
